Yarrow Point Original Grade Guidelines

The Town of Yarrow Point requires that an "Original Grade" certification prepared by a **licensed surveyor or geotechnical engineer showing the grade** as established by YPMC 17.08.170 be included in the submittal of a building permit application.

Original Grade Certification is a drawing that shows the original grade (as defined by YPMC 17.08.170) contours of the site. The entire site must be included in the original grade drawing because the allowed building height at every point is related to the original grade at that point. This drawing must be prepared and stamped by a licensed surveyor or geotechnical engineer. A survey showing existing grade must also be provided.

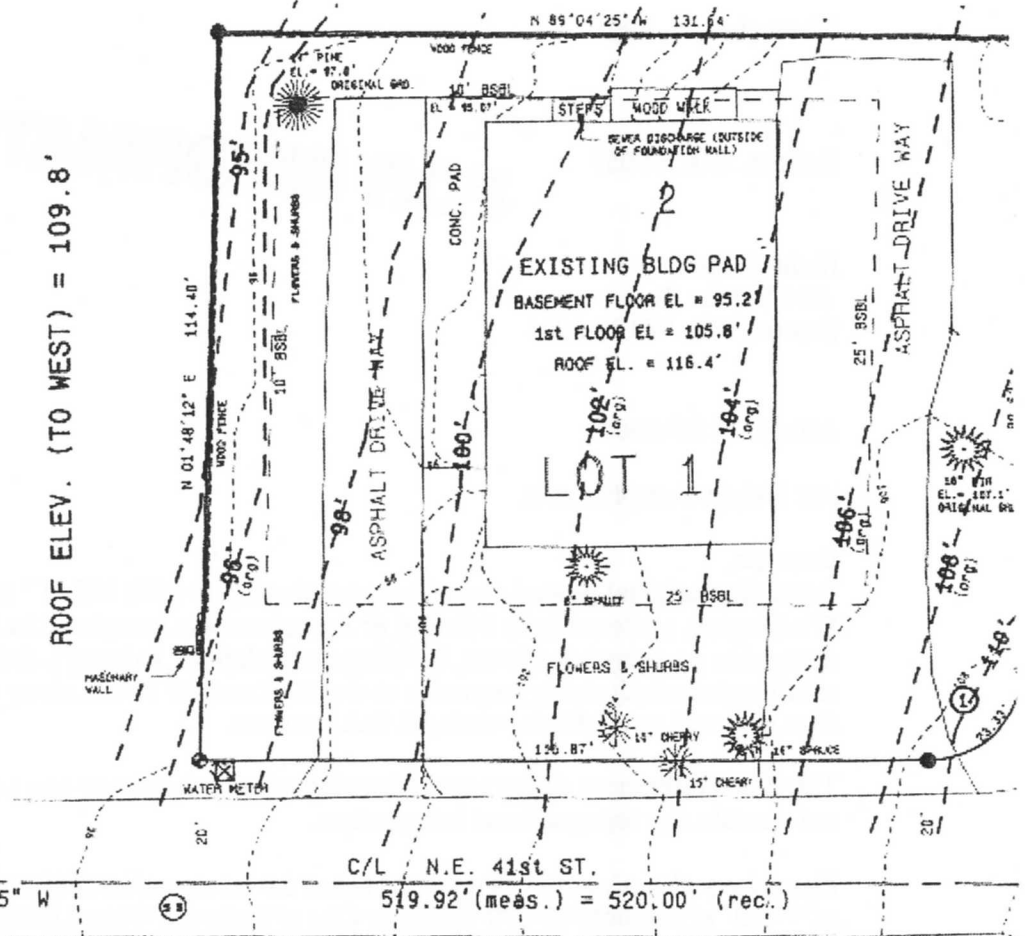
Example 1

1. Original grade contours shown on stamped drawing with legend to identify the contours. Existing grade contours are included on the original grade drawing in this example.
2. Stamped letter from surveyor outlining basis of original grade shown.

ORIGINAL CONTOURS ARE SHOWN AS BOLD
EXISTING CONTOURS ARE SHOWN AS FINE
CONTOUR INTERVAL = 2'

Regarding original ground elevation determination at 9072 NE 41st St. in Yarrow Point, Washington, a site study by Michael & Associates was completed in June of this year to determine property boundaries, building set back lines, existing building footprint, and roof heights of adjoining properties to the West and the North, along with topographical data gathered to establish existing 2 foot contours.

I based my elevation studies upon the sewer invert elevation of 89.67' and rim elevation of 97.03' at manhole 03-130/ #E-5 per City of Bellevue Water Utility Map, C-2 (this is the sewer manhole located in NE 41st St., opposite the S.W. property corner of this site and is the connection for the sanitary sewer on this project). There is a significant difference in datum's in this area and for that reason I elected to use what I considered to be the most critical for this project, the sewer, and convert all elevation data to this benchmark.

Using this approach, there is a difference of approximately 6.0' between the City of Bellevue Utility District sewer datum and the original preliminary plat datum. I held the Utility District datum and converted the preliminary plat contours to it.

I proportioned the contour interval distances along the north and south boundary lines based on the original ground elevations at the base of the afore mentioned trees and held the contour relationship (shape/flow) relative to the original preliminary plat to the best of my ability. I also proportioned elevations on a line between the spruce tree and the pine tree to estimate a point of articulation, if any, along the contour lines. The west boundary is the exception, because of the pine tree base elevation, I paralleled the west boundary for approximately 50' southerly and then angled west to the proportioned mark I established along the south boundary.

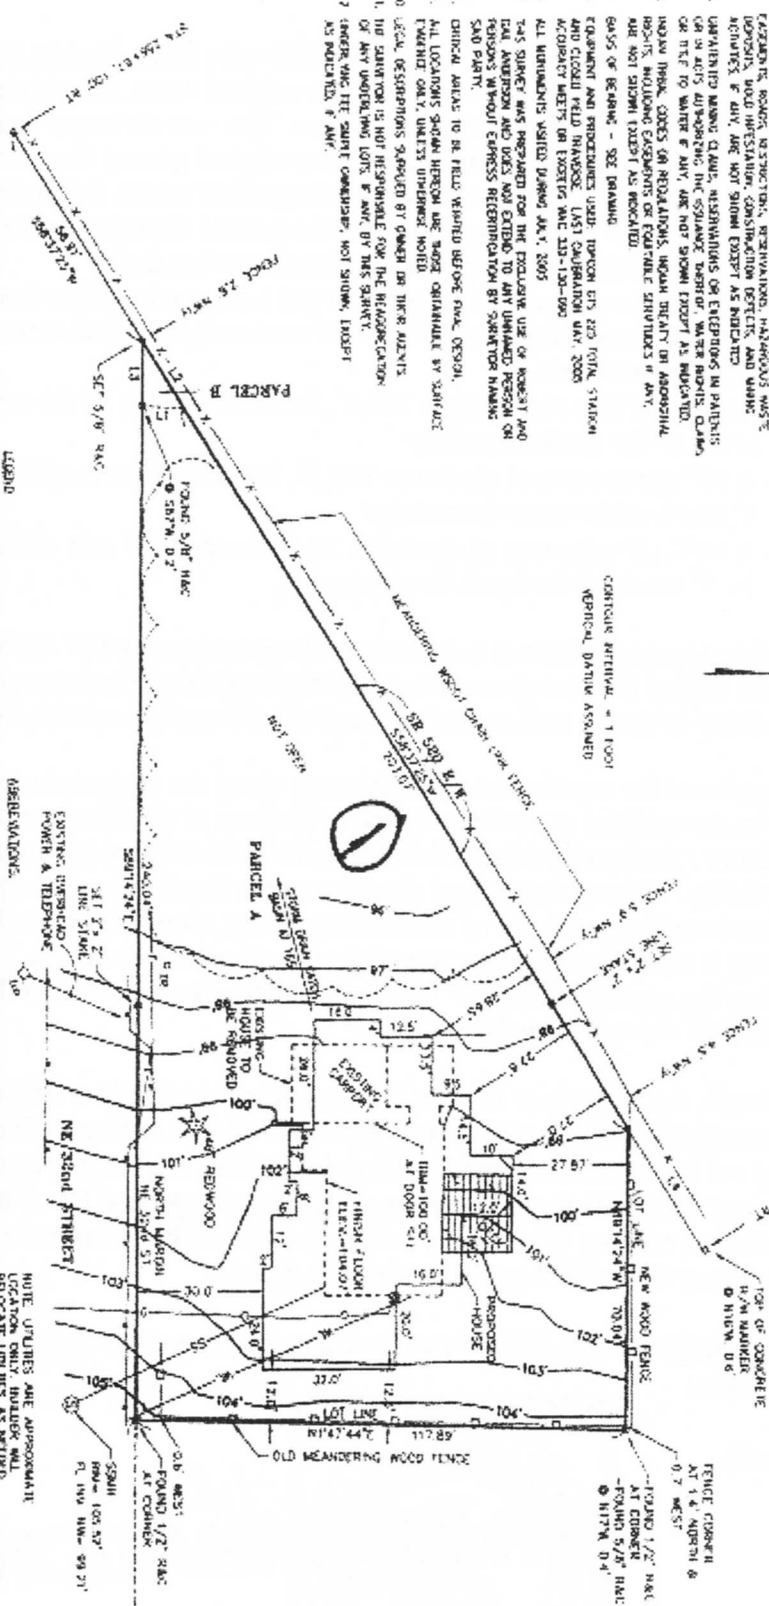
SITE PLAN 1

1. Original grade contours shown on stamped drawing. Existing grade contours were provided on a separate survey.
2. Surveyor's note showing documents researched and used for basis of original grade.

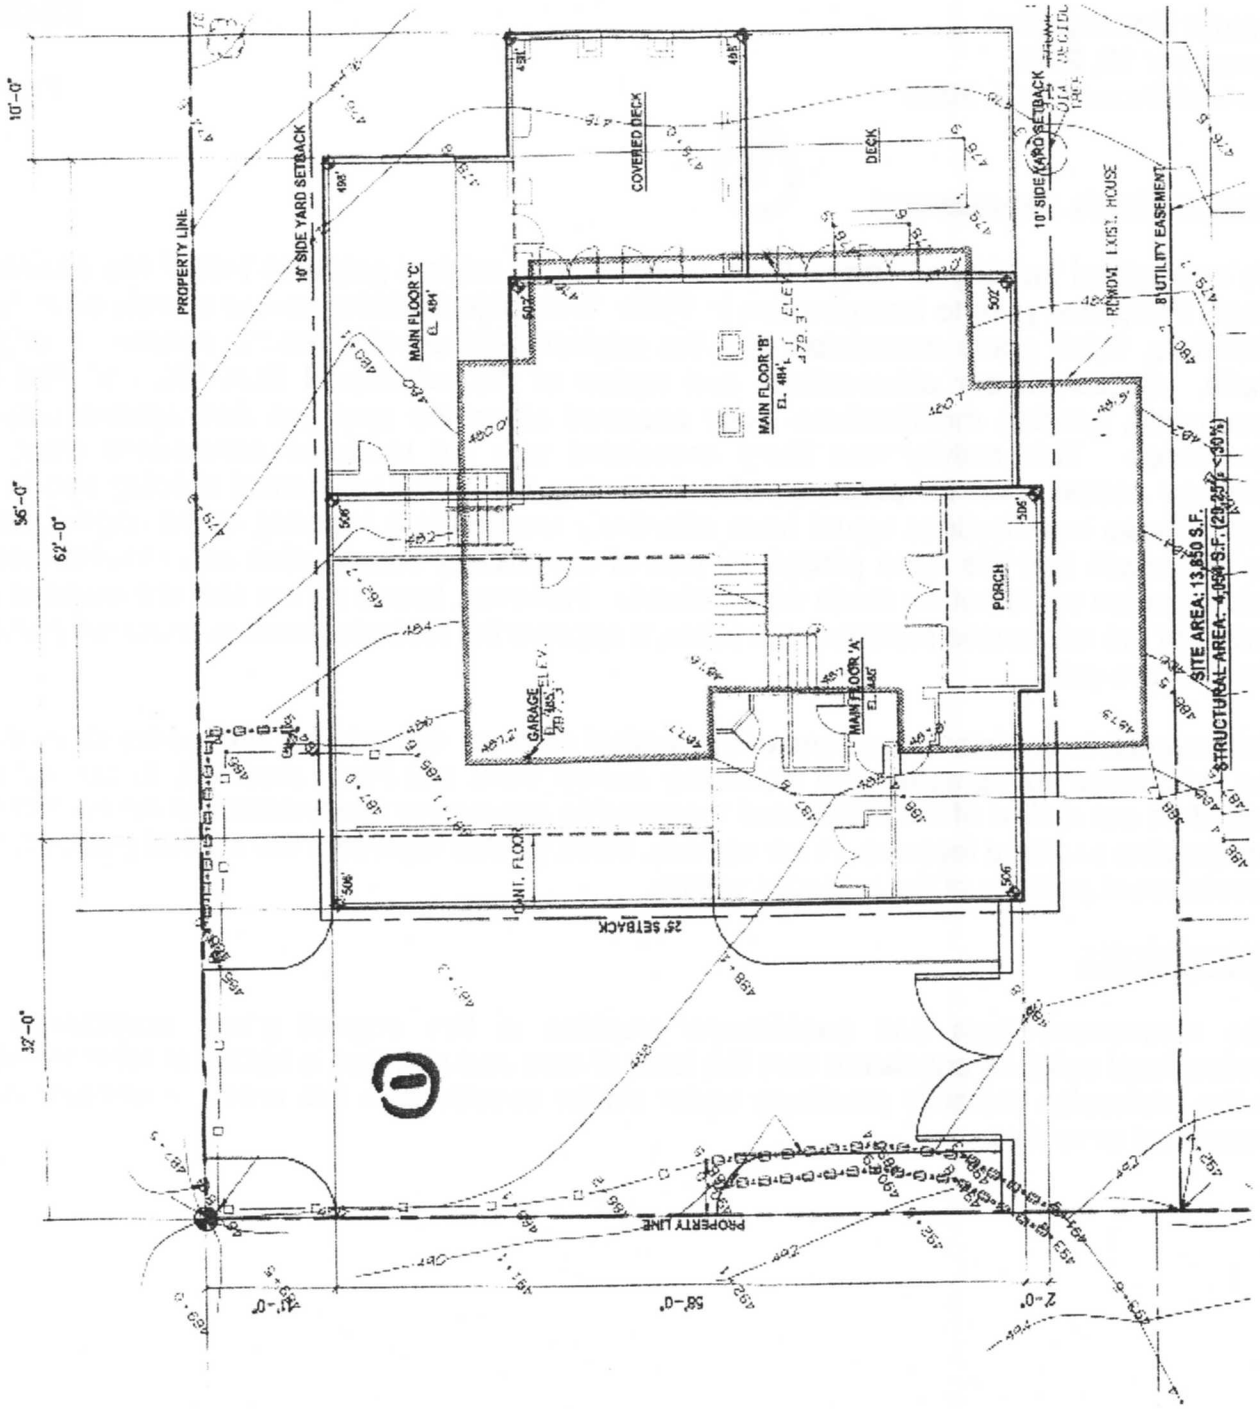
Example 3

1. Existing grade survey of site is shown.
2. Stamped letter verifying that in this case the existing grade is also the original grade. Letter outlines basis of the original grade.

We understand the City of Yarrow Point recognizes an original grade as that of any developed parcel completed prior to incorporation in 1959. The subject residence was completed in 1926. Therefore, finish grade associated with the original 1926 development is considered original grade. Based on our observations and review of the referenced BLA #52 and Plat #31 documents, grading modifications likely occurred along the southern and eastern property boundaries. This activity was likely associated with cut rockeries constructed along the driveway access, and for purposes of establishing the newer residential building pad to the east. These modifications would have effectively resulted in a lowering of the original grade. To the extent that fills were placed as part of the rockery construction and modifications, a determination could not be made with certainty. However, based on our site observations and review of the referenced historical site plans, it appears the rockeries were constructed primarily along native cuts.

With respect to the interior portions of the subject property, the existing site grades depicted on the referenced topographic and boundary survey have not been modified, in our opinion. Based on our review of the referenced topographic survey and observations of the surrounding topographic and land features, in our opinion, these grades represent the original grades for the development portions of the subject property.

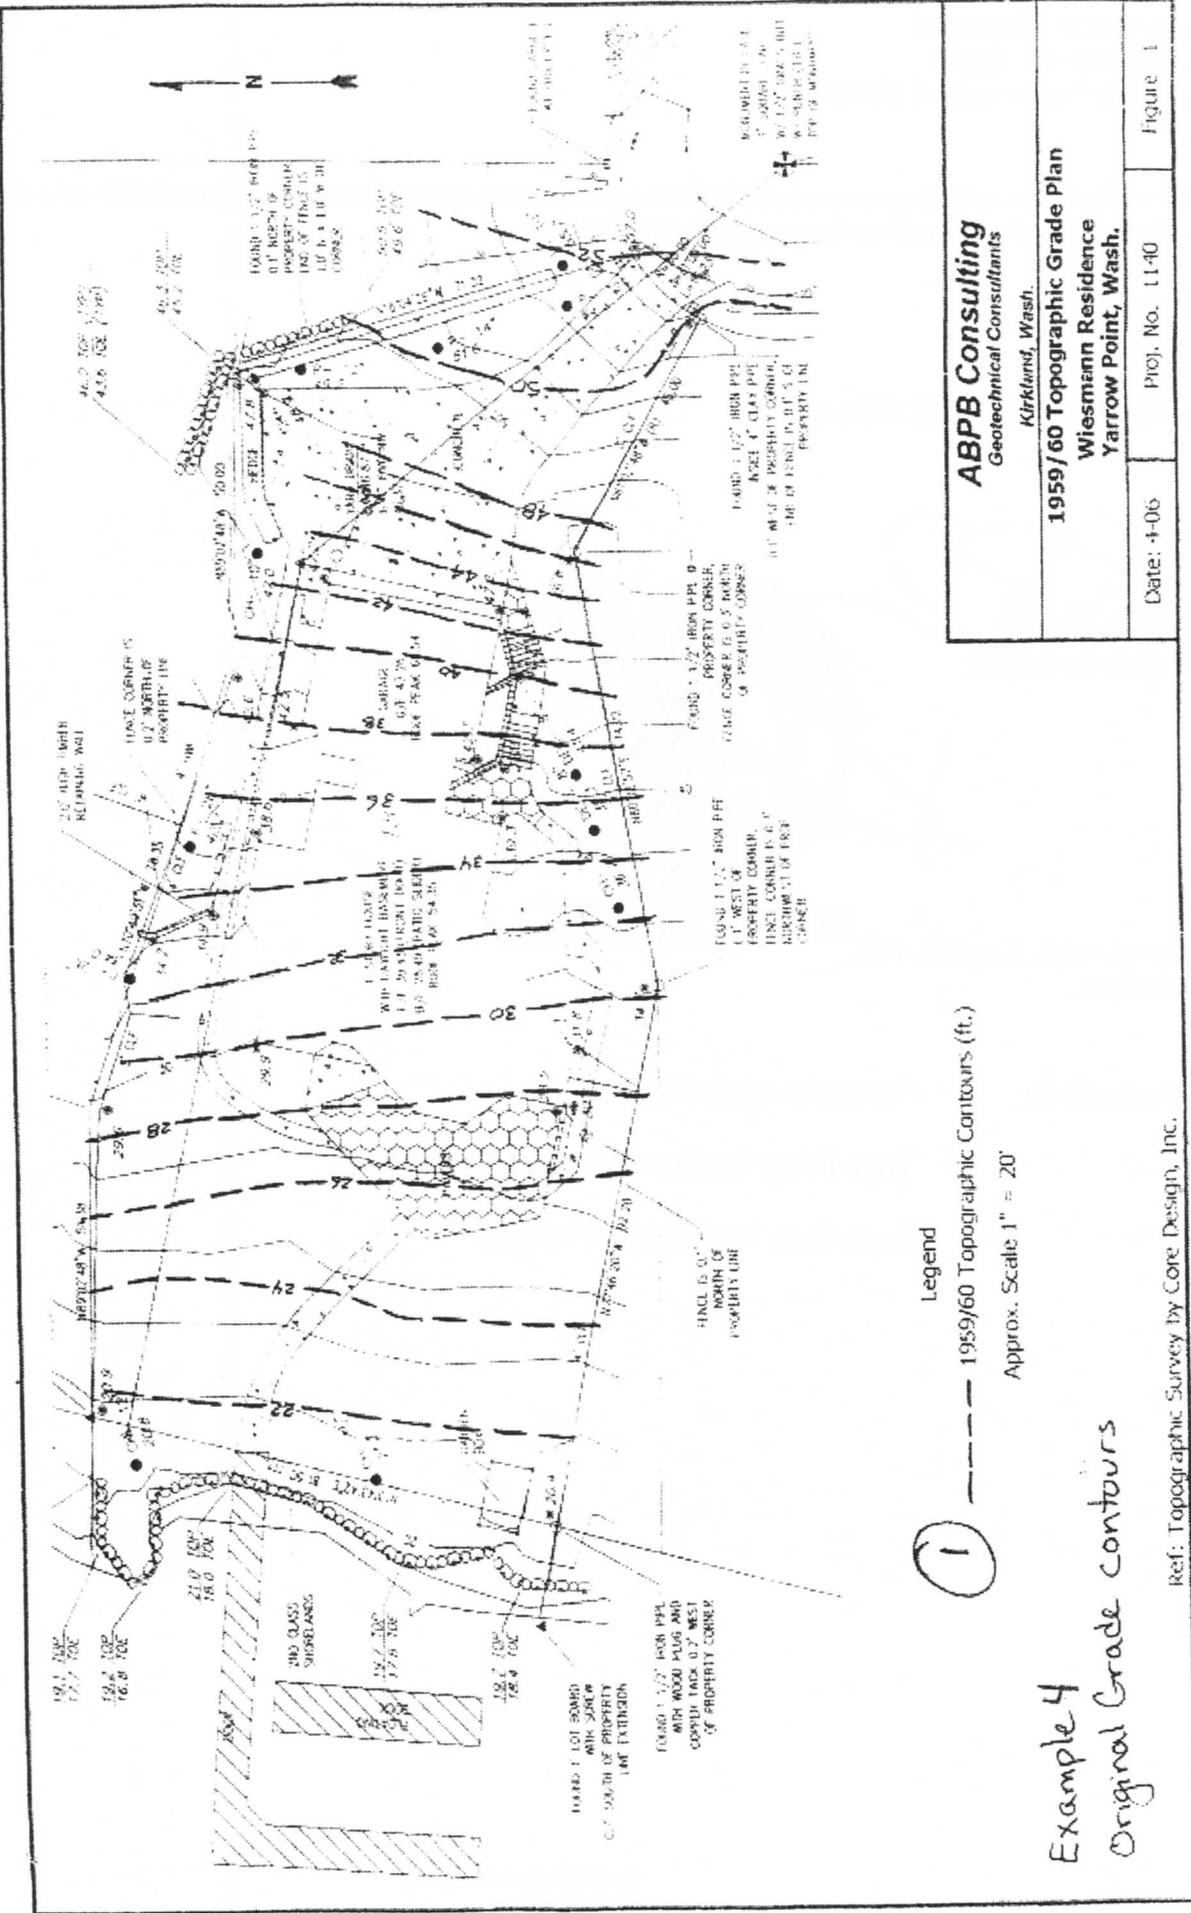
Figure 1

1. Original grade shown as dark contours. A separate stamped letter outlining the method for determining Original grade was also provided by the geotechnical engineer. (Not shown)
2. Architect overlaid proposed roof plan over the original grade contours and labeled the proposed height of each roof peak in order to show compliance with the Town's height requirement at all points along existing grade.

1959/60 Topographic Grade Plan
Wiesmann Residence
Yarrow Point, Wash.

① - - - - 1959/60 Topographic Contours (ft.)

Example 4
Original Grade contours
